Bugs in the BOSS GS-10

9 August 2005
Mark van den Berg

The BOSS GS-10 Guitar Effects System is a great device. However, the GS-10 does seem to contain several bugs, which may have to be fixed by means of a firmware upgrade. This document describes these problems.

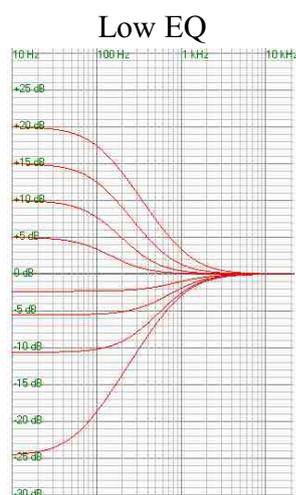
The GS-10's frequency responses for the Low EQ and High EQ parameters of the Equalizer and Stereo Equalizer effects are wrong for values below 0 dB:

The frequency response plots below (generated by a third-party frequency sweep program) show the GS-10's actual responses for several values of the Low EQ parameter (where the Lo-Mid, Lo-High, High EQ and Level parameters are kept at 0 dB). The table (on the right) picks out a few relevant values. (Note: these values can even be estimated if one sends a 20 Hz signal to the GS-10 and then checks the values produced by the GS-10's own Meter.)

Low EQ parameter	Actual response at 20 Hz
+20 dB	+20.0 dB
+15 dB	+15.0 dB
+10 dB	+10.0 dB
+5 dB	+5.0 dB
0 dB	0.0 dB
-5 dB	-2.3 dB
-10 dB	-5.5 dB
-15 dB	-10.7 dB
-20 dB	-24.0 dB

Thus, for most values below 0 dB the actual cuts are substantially *less* than what they should be, but for -20 dB the cut is *deeper* than it should be!

The cause of this weird behavior must be a confusion between linear and logarithmic scales in the GS-10's algorithms for the Low EQ parameter: I have found that the GS-10's actual responses for the Low EQ values below 0 dB can be approximated by means of a formula like $20 \times {}^{10}\log(1 + 0.04705 \times x)$, where x stands for the Low EQ value.

The High EQ parameter's behavior is wrong in roughly the same way as described above for the Low EQ parameter.

Since it's just a matter of changing a few fixed parameter values in rather simple low- and high-frequency shelving filter algorithms, it should be relatively easy to fix this problem in the GS-10. (Obviously, current users would have to be warned that their patches might start to sound different if their GS-10s are upgraded, but personally I would *definitely* prefer the upgrade.)

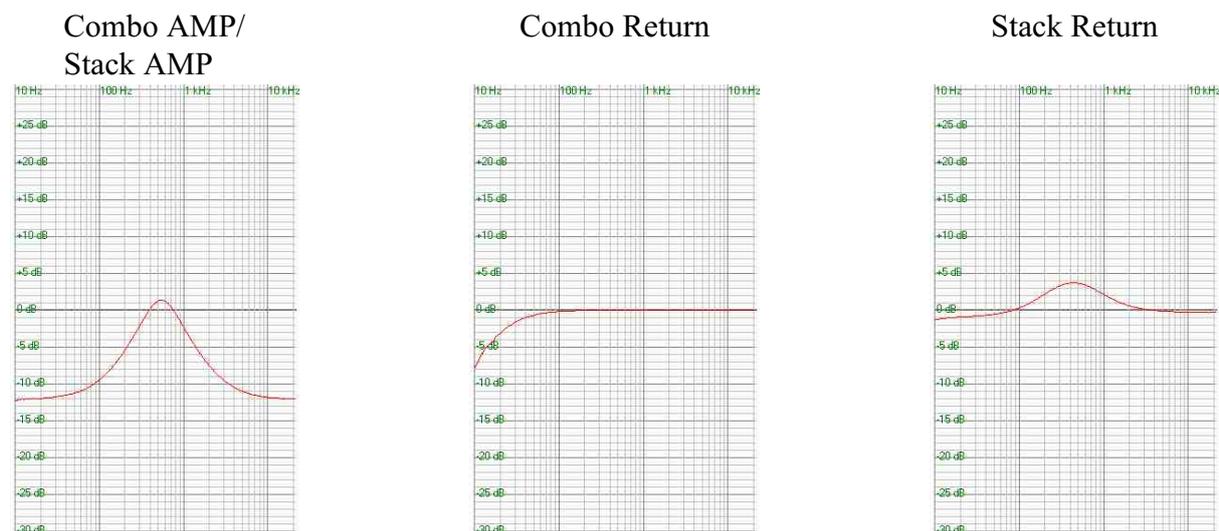
There may be something wrong with the Output Select parameter. I'm not sure whether there is actually a problem here, but I thought I would mention it anyway:

The GS-10's global 'Output Select' parameter has 5 values: Line/Phones, Combo AMP, Stack AMP, Combo Return and Stack Return. However, as far as I could tell, there is *no* difference between the responses for Combo AMP and Stack AMP, as shown in the frequency response plots below. (N.B. Line/Phones is not shown separately: it has a completely flat response.)

Several explanations for this seeming anomaly are possible:

1. There *is* no problem: The above frequency response plots are in fact incorrect or have missed some aspect of Combo AMP and Stack AMP in which these settings *do* differ.
2. The identical responses for Combo AMP and Stack AMP are intentional.
This would be very strange, in view of pp. 16 and 29 of the Owner's Manual, where Combo AMP and Stack AMP are mentioned separately in several pieces of setup advice.
3. The identical responses for Combo AMP and Stack AMP are caused by a design error in the GS-10. If this is the case, the problem should be corrected.
